## Scientific Documentation of Malhargad, Pune District, Maharashtra

**Pranjali Shahane and P.D. Sabale**

*Deccan College Post Graduate and Research Institute,  
Deemed to be University, Pune*

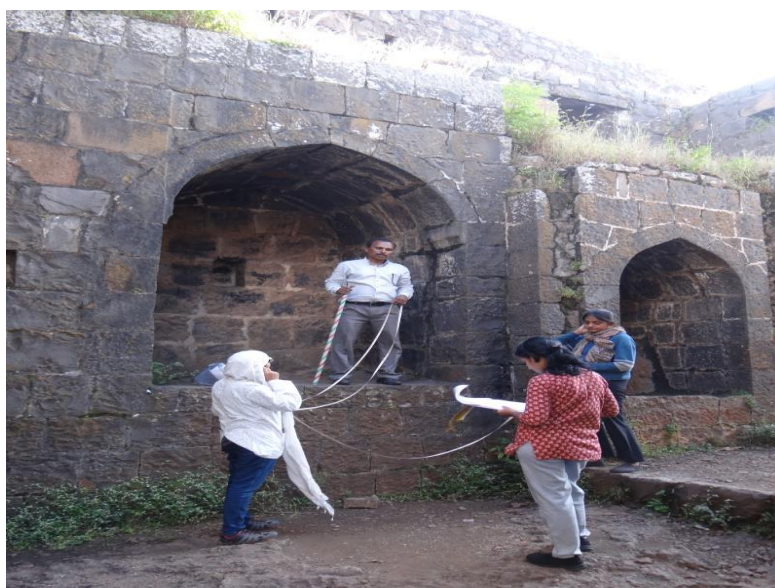
Fig.3 Shows the team is busy in documentation of Eastern main gate at the fort site

| | Arch<br>105-120 | An arch of 2.5x2.0x1.0 height, width and depth respectively were found.<br>The surrounding region is covered with small vegetation (Fig.3). | |
| | Arch<br>120-135 | The lime in the left side stony wall has been washed<br>The joints are becoming open.<br>The vegetation is grown along such cracks (Fig.3). | |
| 8 | Arch<br>150-165 | i. Arch Shows following dimension -<br>1.2 m., width, 1.6m. Depth and 1.9 m. Height.<br>ii. Displacement of building stone.<br>iii. Decomposition of binding material / cement observed.<br>iv. Vegetational growth on the top of the wall is observed (Fig.3). | |

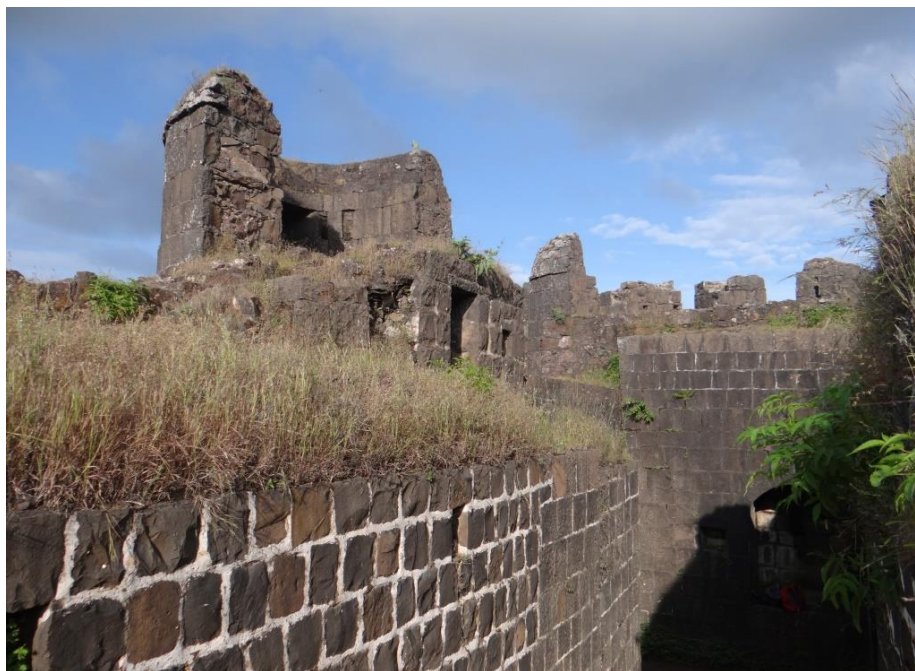
| 30 | Main fort<br>495-505 | i. The upper part of the wall is damaged.<br>ii. Some building stones are displaced.<br>iii. Cement is washed out, resulting vegetation growth is observed along the gap.<br>iv. Upper part of the wall disturbed while the lower part is intact (Fig. 4) . |
| 31 | Main fort<br>505-520 | i. The upper part of the wall is damaged.<br>ii. At places, stones are displaced.<br>iii. Cement is washed out and resulting vegetation growth is observed (Fig. 4)<br>iv. The lower part of the wall is intact while upper one is disturbed. |

Fig. 4 Picture of the street at the eastern main gate

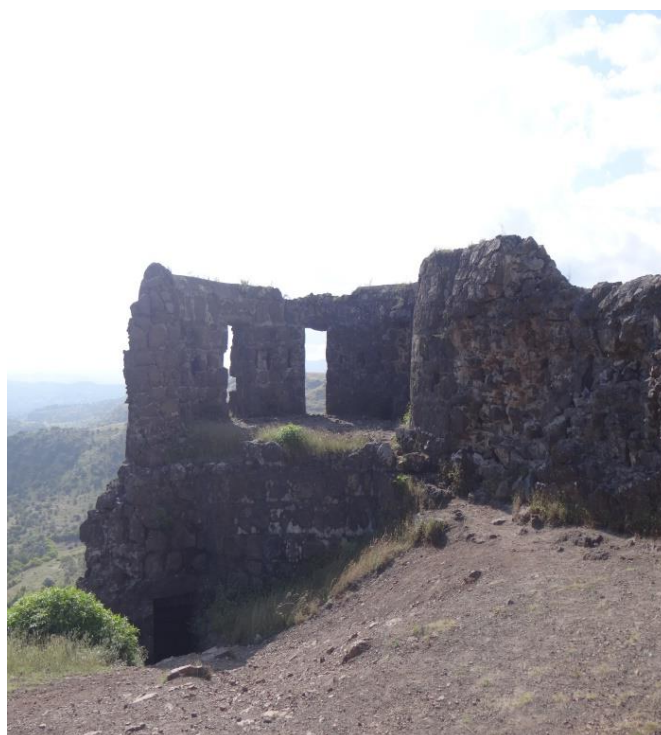
| 32 | Upper terrace<br>520-535 | i. The upper part of the wall is damaged on large scale.<br>ii. At places, the building stones are displaced.<br>iii. At places, the cement is washed out and resulting vegetation growth is observed in such gap.<br>iv. The lower part of the wall is intact condition while the upper one is disturbed (Fig. 5). |

| 33 | Upper terrace<br>535-550 | <ul style="list-style-type: none"> <li>i. Intact wall throughout the area.</li> <li>ii. Numerous gaps are observed in between the two-building stone due to washing of lime.</li> <li>iii. Vegetation growth is observed on large scale.</li> <li>iv. Building stones are affected by chemical weathering (Fig. 5).</li> </ul> |

Fig. 5 Picture of the bastion at the eastern main gate

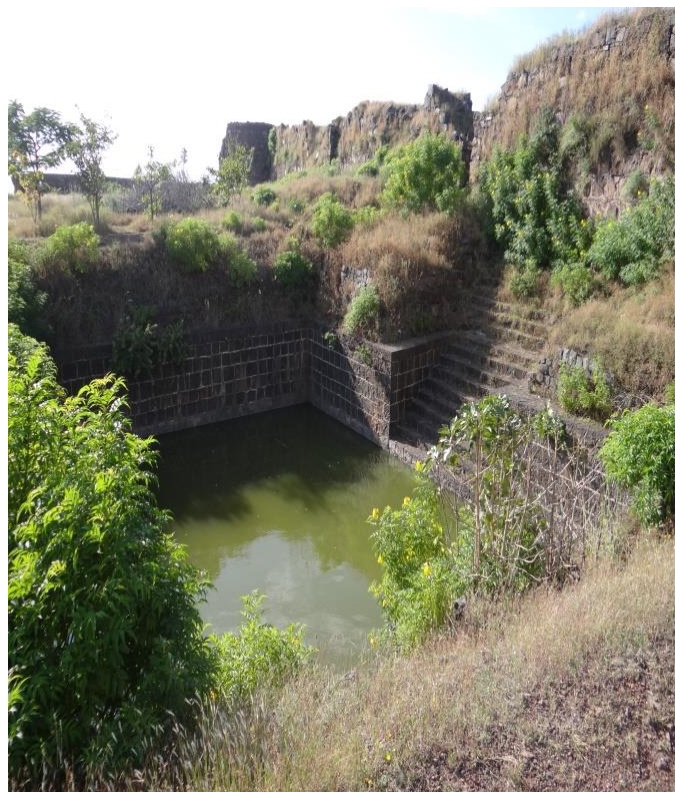
| 54 | Step well one<br>885-900 | <p>i. The whale is having into 13 m dimension.</p> <p>ii. It is a very well-constructed step well located in between the Sonori gate and South Eastern Gate behind the Mahadeva temple.</p> <p>iii. In the present condition, it is showing full of water.</p> <p>iv. It is having the technology to lift the well water to outskirt similarly there is a provision of steps which goes up to the dipper portion of the well.</p> <p>v. Therefore, we can collect the water by manually as well as by lifting process.</p> <p>vi. On the basis of large-scale dimension of the well as well as its capacity to provide the water.</p> <p>vii. To provide the water bulk scale anyone can't understand that it is the only one source of water for drinking and domestic on the fort site (Fig. 6).</p> |
| 55 | Dug-well<br>900-915 | <p>i. Dug-well is present in between Mahadeva temple and the residential structure as well as the step well structure.</p> <p>ii. It is having radius of 7 feet and the depth approximately goes up to 40 feet.</p> <p>iii. In the present condition it is also showing 4 to 5 feet of water.</p> <p>iv. Therefore, it is also a good source of water for the drinking purpose.</p> <p>v. It is constructed by using well-dressed stone.</p> <p>vi. At very few places, lime is washed out at places and gaps are developed in between the two building stones (Fig. 6).</p> |

Fig. 6 Picture of the step well located near the Mahadeo temple
